Improved Definition of Wreck Superstructure using Multibeam Water Column Imaging.

John E. Hughes Clarke⁽¹⁾, Steve Brucker⁽¹⁾ and Kal Czotter⁽²⁾

(1) - Ocean Mapping Group, Dept. Geodesy and Geomatics Engineering
University of New Brunswick, jhc@omg.unb.ca

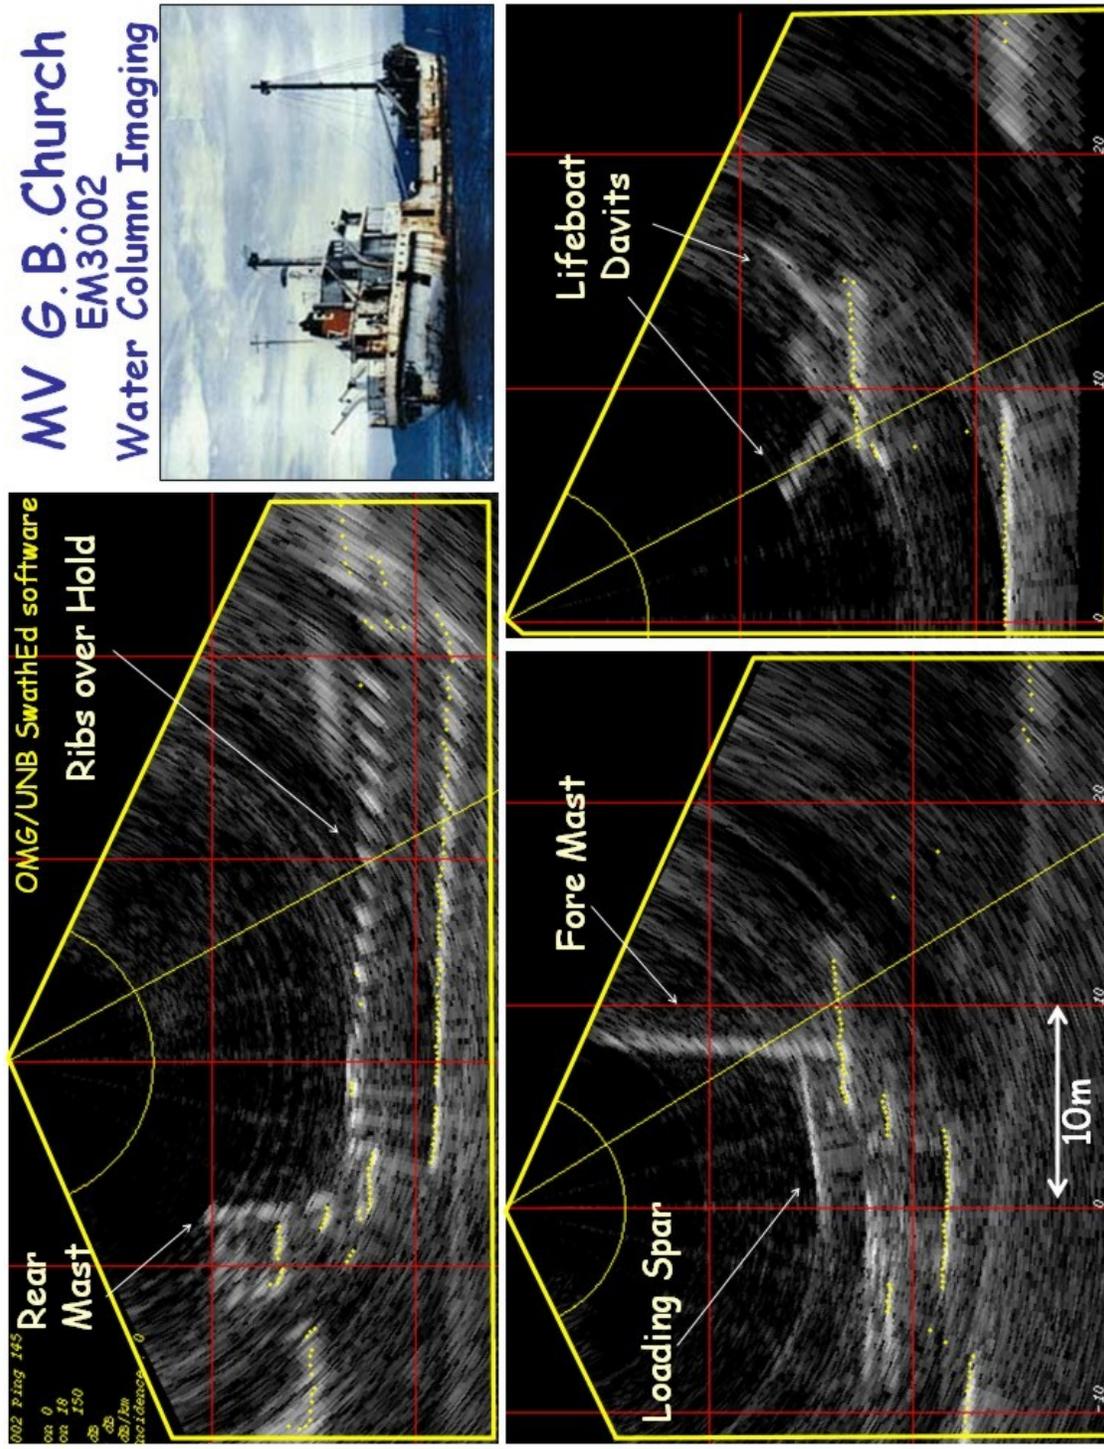
The example images shown here demonstrate the improved efficacy of using the water column imaging capability available with the latest generations of multibeam sonars. In the examples shown, the real-time bottom tracking (yellow dots) is locking on to just a single target (the strongest, or the most like the adjacent) at a given beam-forming angle, whereas, due to the finite beam-width and the presence of sidelobes (Hughes Clarke, 2006), there are often multiple possible echoes at that elevation angle.

In the examples shown, a 60m long wreck in 22m of water is imaged at 8 knots using an EM3002, pinging at 10 Hz. The wreck (the G.B. Church) was deliberately sunk for recreational diving and was photographed extensively as she settled. The exact position and size of all protruding features are thus well known. The water column imaging (processed using the OMG/UNB SwathEd software), clearly reveals all the protruding features including masts, davits, spars and ribs over the hold. The real-time bottom tracking algorithm does not reliably pick up all these targets. By altering the bottom tracking filter settings (to wide open), a greater density of true targets is revealed, but at the expense of false echoes as well (Hughes Clarke, et al., 2006).

By using the water-column imaging, the hydrographer is able to quality assure the spurious outliers in the vicinity of a man-made feature with increased confidence. It is
